NWL Report No. 1741

INVESTIGATION OF 3"/70 CARTRIDGES
FROM AMMUNITION LOT PV-4-C-57

Date: 23 February 1961

Weapons Development and Evaluation Laboratory

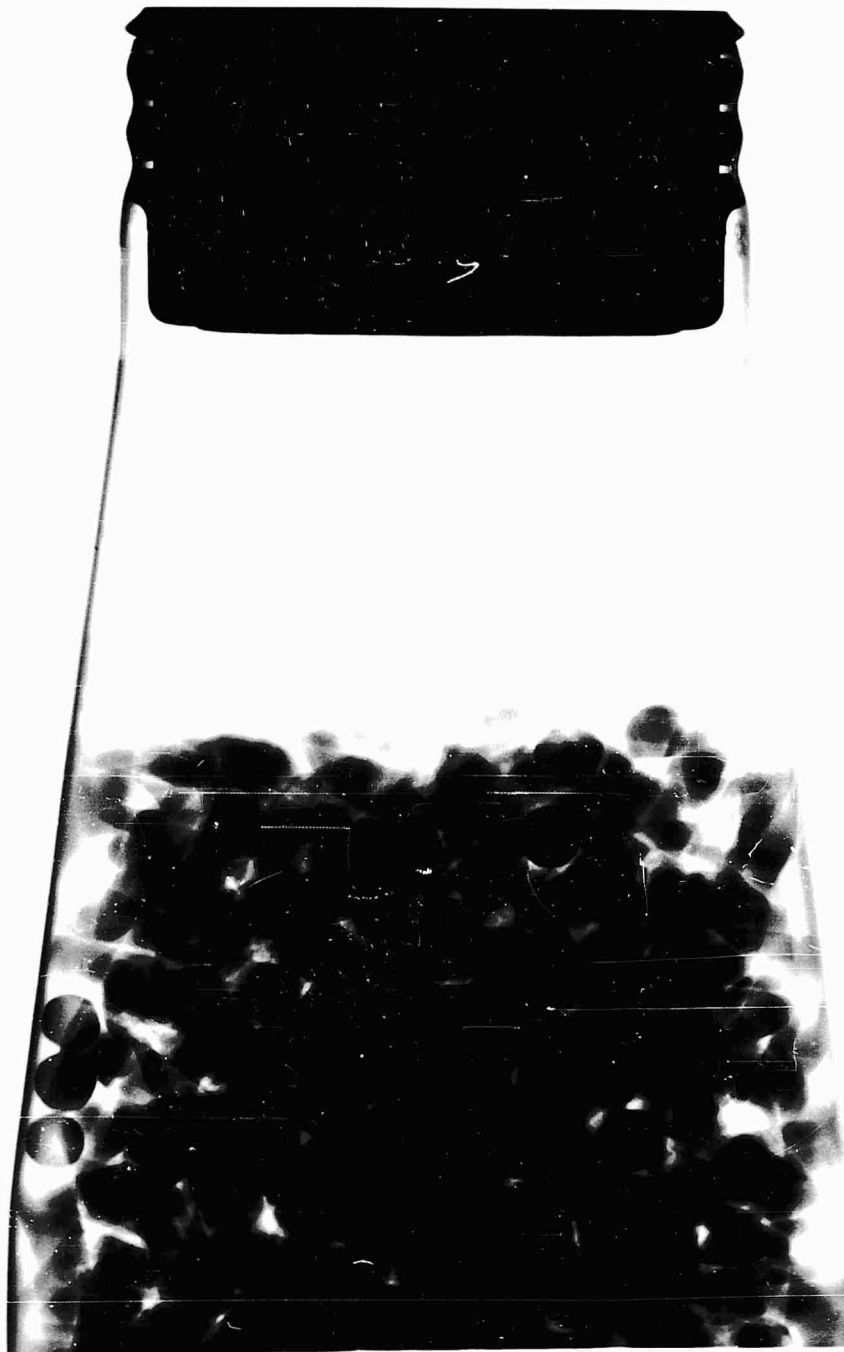
Figure 6

First special round showing sectioned solid propellant grains remaining after one cycle through the Mk 37 Mount.

To investigate the possibility of propellant slivers or black powder becoming wedged between the cartridge case and projectile and subsequently igniting during the ramming process, several ramming tests were conducted. One possibility considered was that a primer might lose its end seal, allowing some of the black powder charge to work forward and eventually become lodged between the cartridge case and projectile. Four cartridges assembled with inert propellant and projectiles, and primers from ammunition lot No. PV-4-C-57 were cycled through the automatic ammunition handling system of the Mk 37 Mount. Subsequent examination showed no change in the end seals. Five cartridges similarly assembled but with the primer end seals removed were also cycled. Subsequent examination showed that the black powder charges remained in the primer tube. In spite of these negative results, for the sake of completeness it was assumed that black powder somehow did get to the forward section of the cartridge case. A special cartridge was assembled which consisted of inert propellant and projectile, with black powder grains and dust distributed as shown in Figure 5, Appendix A. Seven cycles through the Mk 37 Mount failed to ignite the black powder. Two other special cartridges were assembled. Smokeless powder grains were sectioned longitudinally and placed between the cartridge case and projectile. All the other components were inert. The first special round was cycled once through the Mk 37 Mount without ignition occurring and the second special round was cycled ten times without ignition occurring. Figure 6, Appendix A, is a radiograph of the former showing some sectioned grains remaining after cycling and Figures 7 and 8, Appendix A, are radiographs, two views 30 degrees apart, of the latter showing some sectioned grains remaining after cycling. The inert primer used in the second special round was a Mk 45 so that a PPD (Production Facking Depth) could be obtained that was closer to that of the service round.

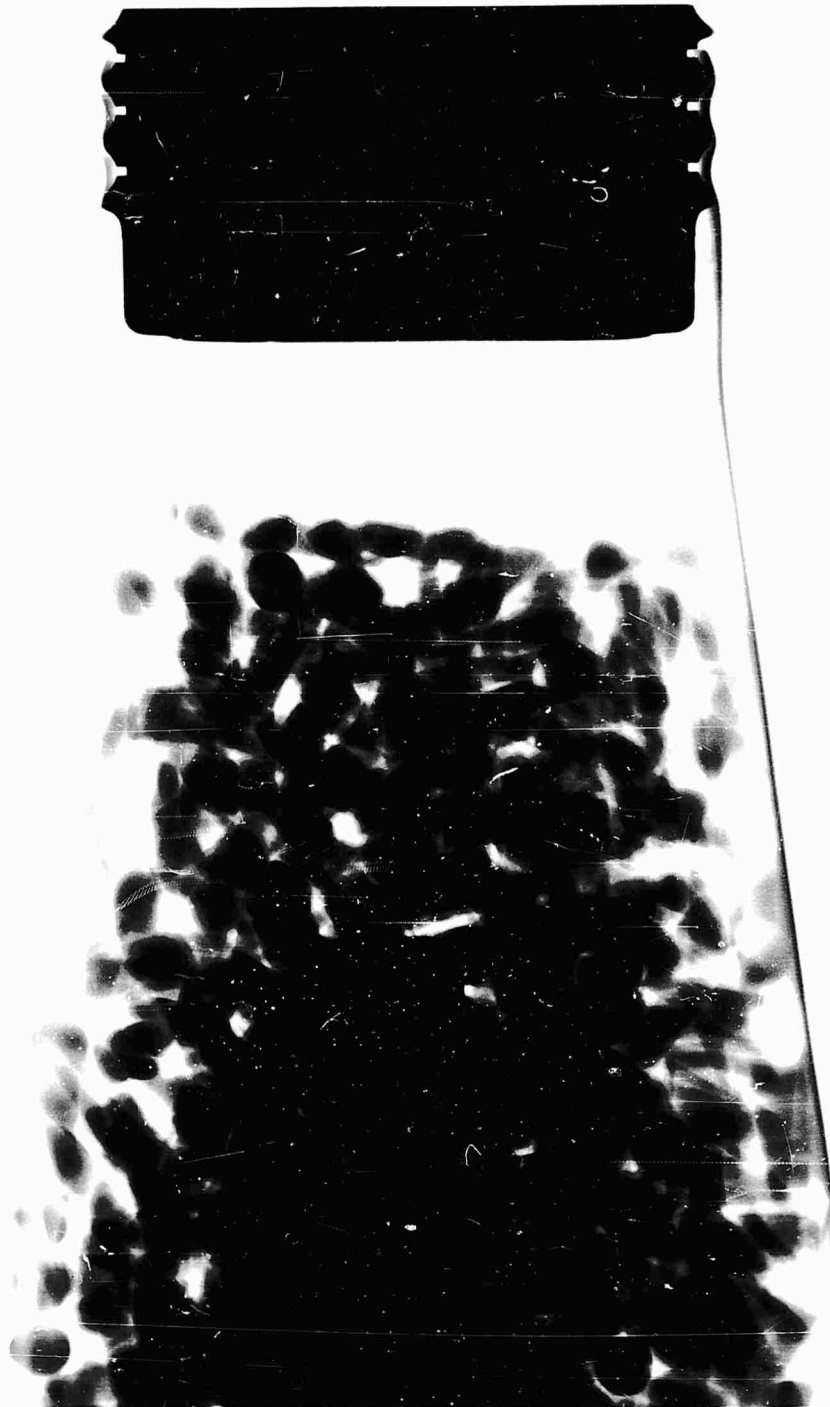
Figure 8

Second special round showing sectioned solid propellant grains remaining after ten cycles through the Mk 37 Mount. Rotated 30 degrees from Figure 7.
